SpaceShip Two: The Anatomy of a Commercial Space Accident

In-Flight Breakup During Test Flight

October 31, 2014

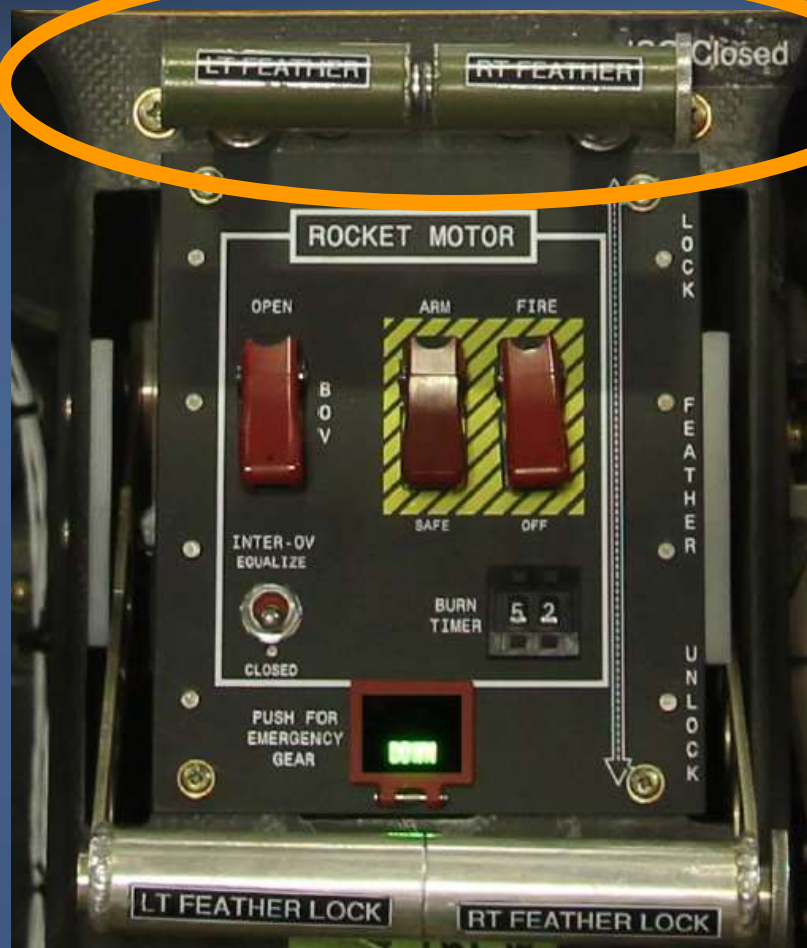
Feather extend handle

PROBLEM: During the transonic region, the upward aerodynamic forces acting on the feather exceeded the ability of the feather actuators to keep the feather retracted.

SOLUTION:
Provide
mechanical
locks to keep
feather
retracted during
this region.

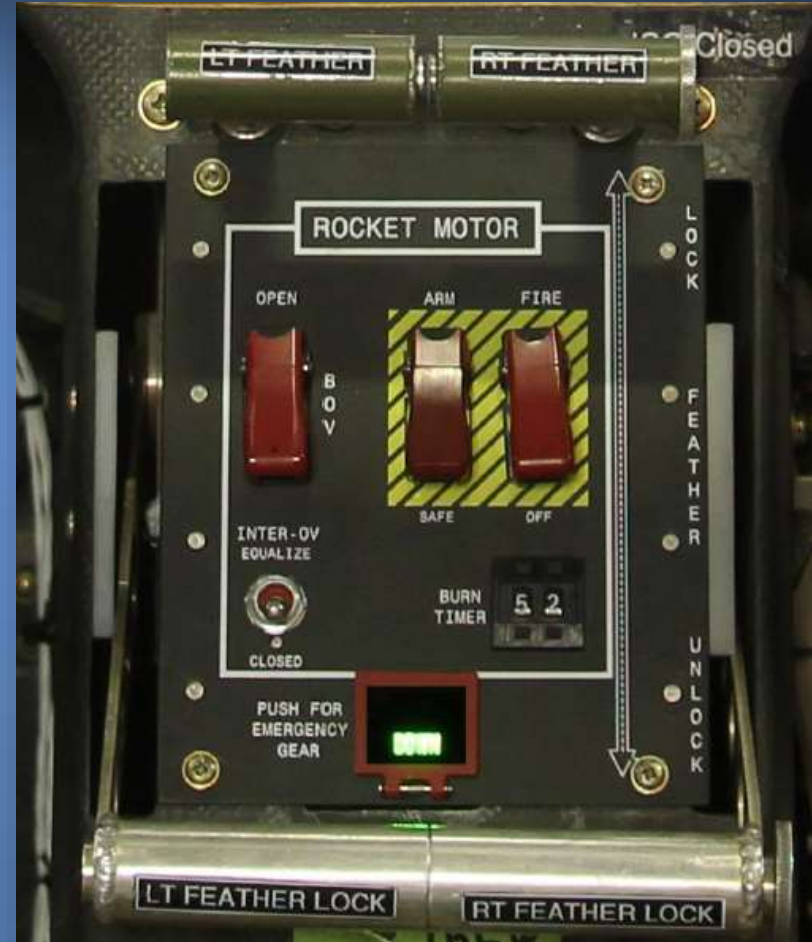
Feather Unlocked

PROBLEM: If feather could not be unlocked, it would pose a very high risk (probably catastrophic) reentry.

SOLUTION: Unlock feather at 1.4 Mach.

If not unlocked at 1.5 Mach, cockpit alert.
If not unlocked at 1.8 Mach, mission abort.

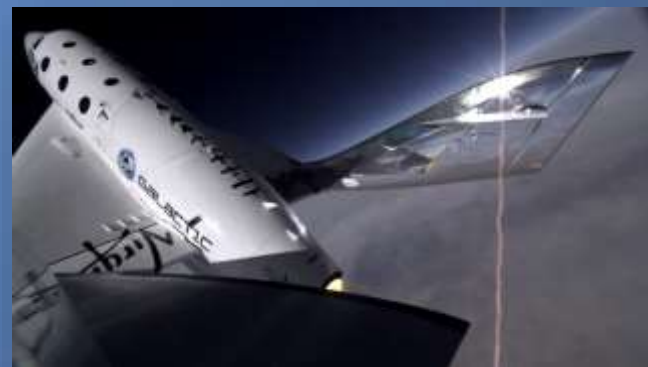
- Copilot made 0.8 Mach callout
- At 0.82 Mach, called out “unlocking” and moved feather handle to unlocked position
- Video and telemetry stopped
